## HemoSphere Advanced Monitor Release Notes

### HemoSphere advanced monitor anomalies for software release version 2.00.000.025

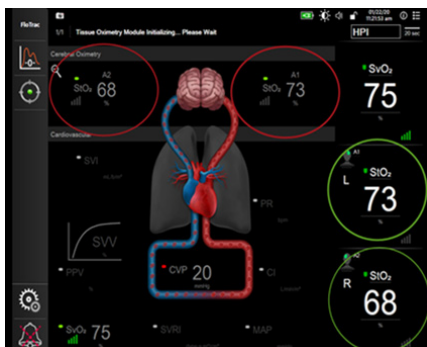
The absolute regional hemoglobin oxygen saturation of blood under the sensors (StO <sub>2</sub> ) parameter value, which is displayed on multiple screens of the HemoSphere advanced monitoring platform, may freeze on the main area of the physiology screen. This partial screen freezing (shown below), with the parameter values circled in red. The same information is also provided in the tiles on the right side of the screen, (circled in green), which perform and update as intended.	Incorrect implementation of event handler for StO <sub>2</sub> tile refresh on the cerebral oximetry/cardiovascular Physiology screen resulting in displayed StO <sub>2</sub> parameters on this screen not updating.	<p>Edwards Lifesciences advises utilizing alternate key parameter tiles and physiology screens (pictured below) when monitoring StO<sub>2</sub> until a subsequent software update is made available to resolve this anomaly. These tiles/screens perform and update as intended. The HemoSphere monitor offers several monitoring screens; two of these screens offer similar functionality to the cerebral oximetry/cardiovascular physiology screen and are recommended as alternatives:</p> <ol style="list-style-type: none"> <li>1) Physiology full body tissue oximetry screen</li> <li>2) Physiology cerebral tissue oximetry screen</li> </ol>
