HemoSphere Advanced Monitor Release Notes

HemoSphere advanced monitor anomalies for software release version 2.00.000.025

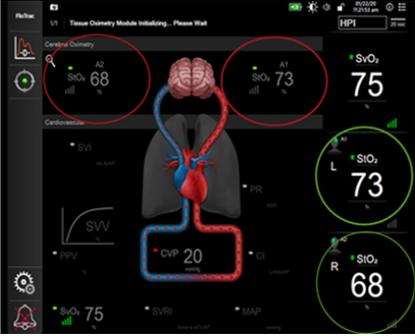
The absolute regional hemoglobin oxygen saturation of blood under the sensors (StO ₂) parameter value, which is displayed on multiple screens of the HemoSphere advanced monitoring platform, may freeze on the main area of the physiology screen. This partial screen freezing (shown below), with the parameter values circled in red. The same information is also provided in the tiles on the right side of the screen, (circled in green), which perform and update as intended.	Incorrect implementation of event handler for StO ₂ tile refresh on the cerebral oximetry/cardiovascular Physiology screen resulting in displayed StO ₂ parameters on this screen not updating.	Edwards Lifesciences advises utilizing alternate key parameter tiles and physiology screens (pictured below) when monitoring StO ₂ until a subsequent software update is made available to resolve this anomaly. These tiles/screens perform and update as intended. The HemoSphere monitor offers several monitoring screens; two of these screens offer similar functionality to the cerebral oximetry/cardiovascular physiology screen and are recommended as alternatives:

<p>1) Physiology full body tissue oximetry screen</p>

<p>2) Physiology cerebral tissue oximetry screen</p>
